Riviera Close Coupled Pan Open back WhiteRIV9Riviera Close Coupled Pan Full BTW WhiteRIV10Riviera Close Coupled Cistern incl. fittings WhiteRIV11

Burlington

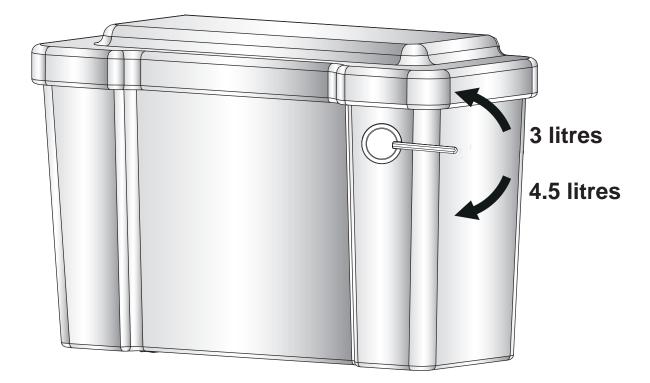
All WC's come with a 3/4.5 litre flush as standard. For lever flush cistern fittings, you must press the lever down lightly for the 4.5 litre flush and lightly lift the lever for the 3 litre flush.

Please note that it is imperative that there are no loops or kinks in the yellow tube when installed and that the lever is not operated with excessive force as this will damage the cable inside the tube that lifts and lowers the flush valve causing the flush to fail beyond repair

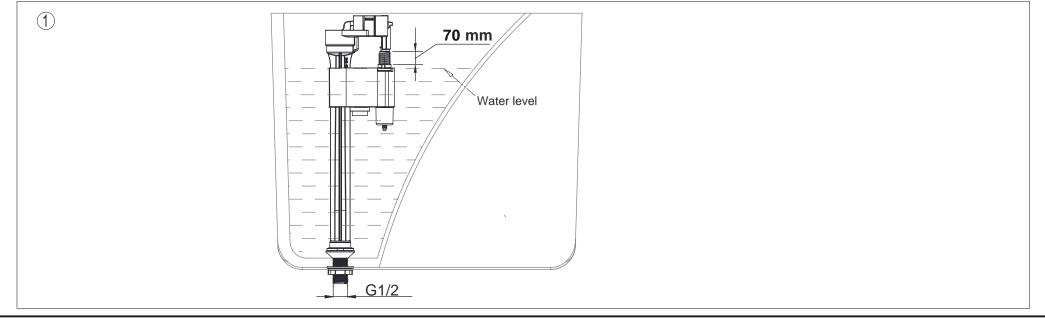
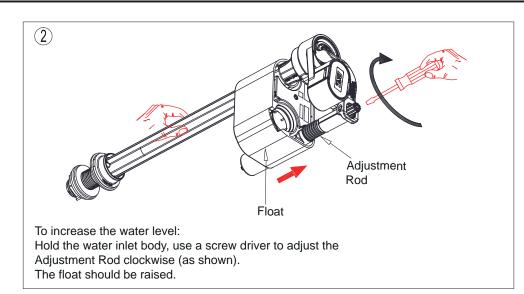
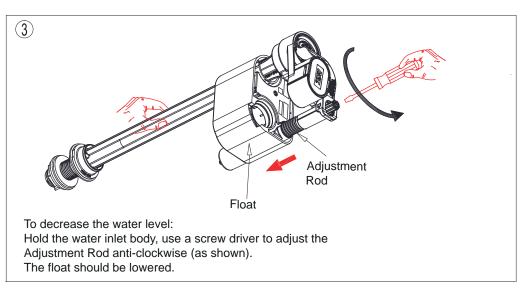
1: Inlet Valve scale and adjustment settings

- Please read these instructions carefully to avoid damage to the valves, and to ensure correct installation.
- Do not use bleach or bleach based cleaning products in the cistern, as these will cause damage to the seals.
 We cannot be held responsible or liable for any failure which results from the use of bleach based products.
- Water temperature range +2C to +45C.
- Water pressure 0.2 to 8 bar.

Problem	Reason	Solution
Incorrect water level	Incorrect adjustment. Adjust the Water level correctly as per page 1 & 2 .	
Inlet Valve does not work	Water supply is closed.	Open the water supply
	The filter is blocked.	Clean the filter.
	The Stop Float has been over adjusted beyond its operational range.	Reconnect the Adjustment Rod, and adjust the water level as per page 1 & 2.
Leakage	The Inlet Valve fixing nut has not been tightened.	Tighten the nut.

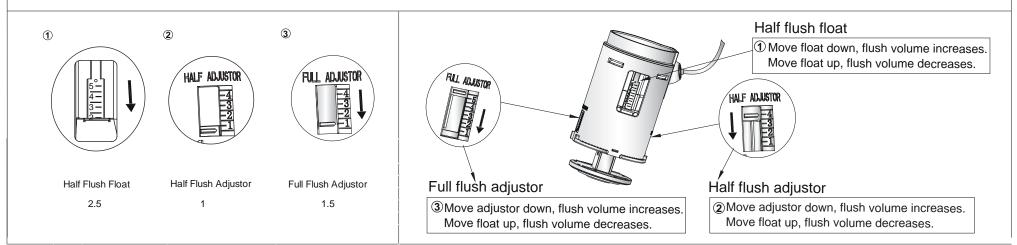
1: Flush Valve scale and adjustment setting

Note: The below diagram ① is set to 2.5,② is set to 1, and ③ is set to 1.5. For adjustment method, please refer to the adjustment setting on right side.

Problem	Reason	Solution
Leakage	 Incorrect installation. Flush valve seat does not fit flush valve body. Flush valve body is stuck. 	 Install again according to the correct installation procedure. Install again. Disconnet and wash flush valve body.
No flush, low flush or half flush volume	Cable is distorted.	Remove kinks or sharp bends in the cable.
Half flush water level is too high or too low.	Water level is adjusted incorrectly.	Adjust water level.
