How to Access your cistern

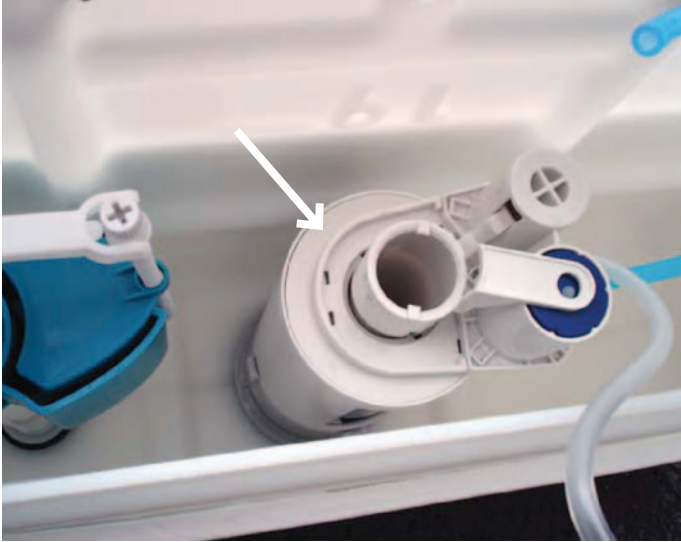
1

Check the flush valve mechanism is fitted as shown here and does not touch / interfere with the cistern casing.

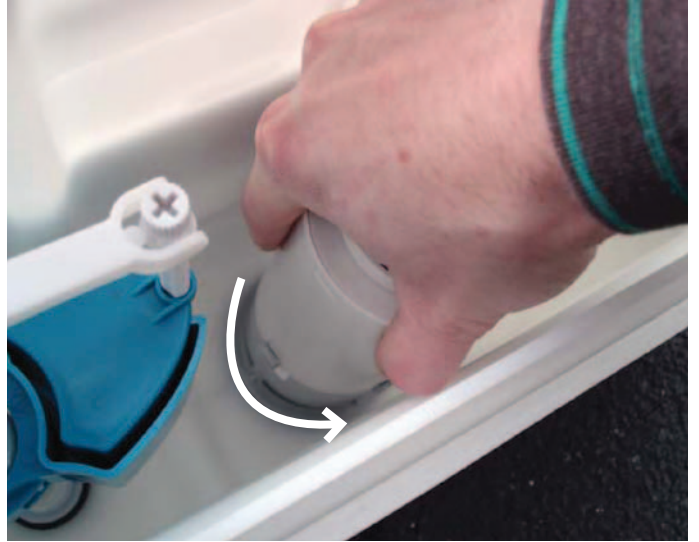
2

Remove the flush valve assembly by gripping the body and rotating anti-clockwise.

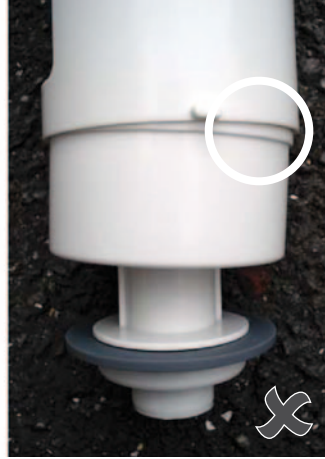
5

Before re-fitting the flush valve assembly check the base is correctly seated as shown. Also check there are no damaged (e.g. snapped) components.

Once re-fitted lift the flush valve piston and release, it should drop back down without any jamming or friction. If the problem persists contact the Roper Rhodes sales office to obtain a replacement flush valve assembly (spare code: SP12166).

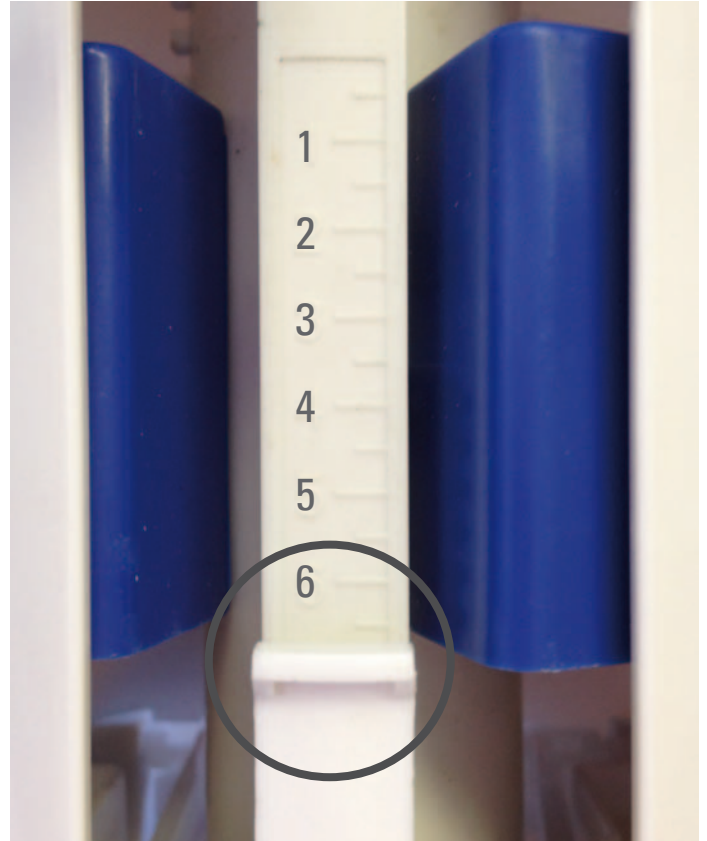
Large flush volume

The white plastic slider controls the large flush volume. This should be pre-set to between 6 and 7. Moving it further down increases the large flush volume and up decreases the large flush volume.
