How to Access your cistern

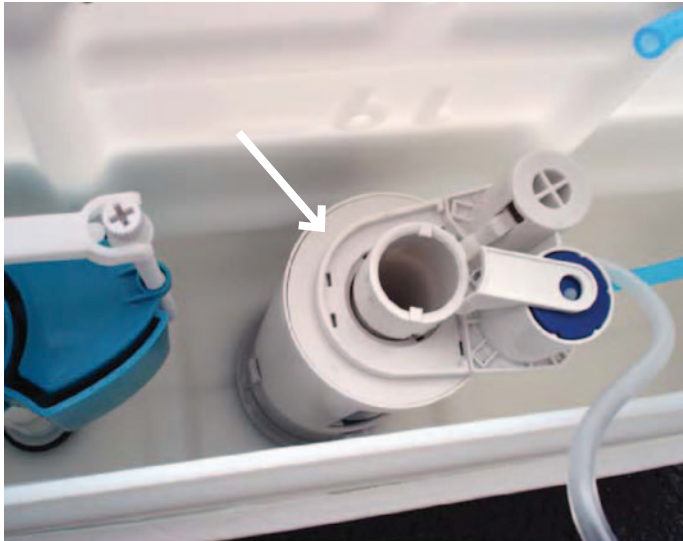
1

Check the flush valve mechanism is fitted as shown here and does not touch / interfere with the cistern casing.

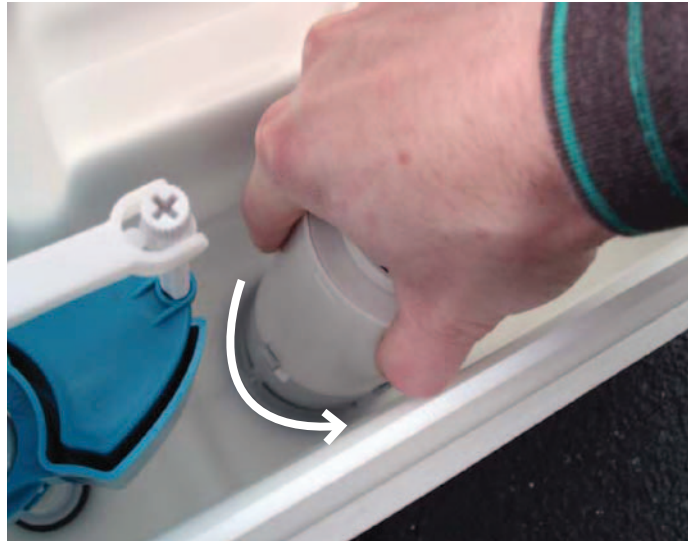
2

Remove the flush valve assembly by gripping the body and rotating anti-clockwise.

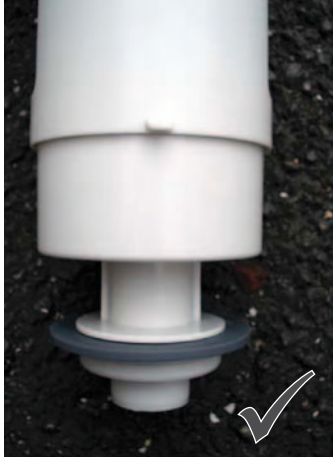
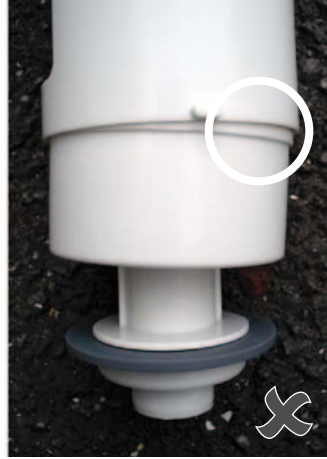
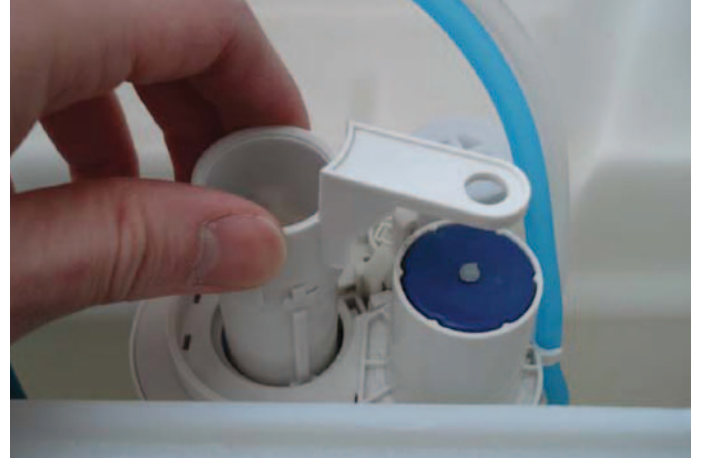
5

Before re-fitting the flush valve assembly check the base is correctly seated as shown. Also check there are no damaged (e.g. snapped) components.

Once re-fitted lift the flush valve piston and release, it should drop back down without any jamming or friction. If the problem persists contact the Roper Rhodes sales office to obtain a replacement flush valve assembly (spare code: SP12166).

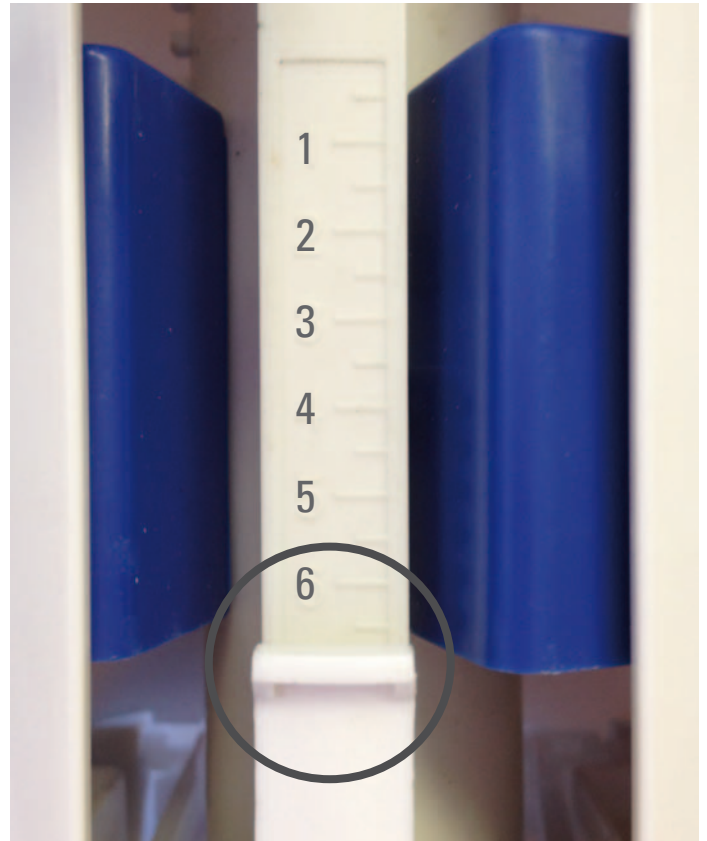
Large flush volume

The white plastic slider controls the large flush volume. This should be pre-set to between 6 and 7. Moving it further down increases the large flush volume and up decreases the large flush volume.
